MERP LEVEL 2 ENERGY ASSESSMENT

Belvidere - Town Clerk's Office
3996 VT Route 109
Belvidere, VT 05442

October 19, 2023

Re: MERP LEVEL 2 ENERGY ASSESSMENT
Belvidere - Town Clerk's Office
3996 VT Route 109
Belvidere, VT 05442
Nova Project No.: SE23-7260

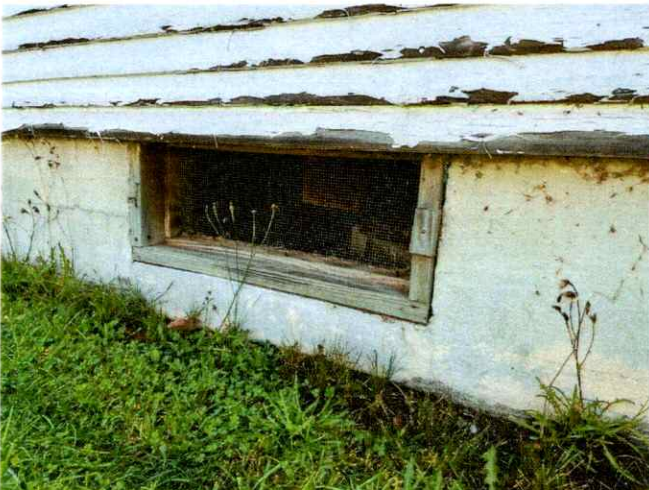
Cellar windows, typical

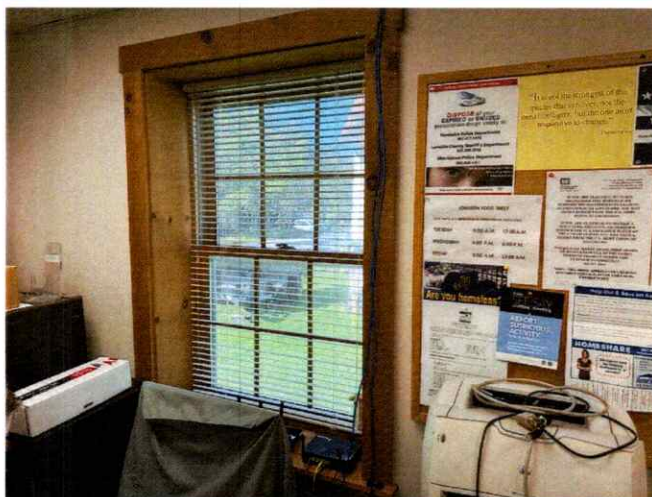
Typical double hung window, wood frame, double pane

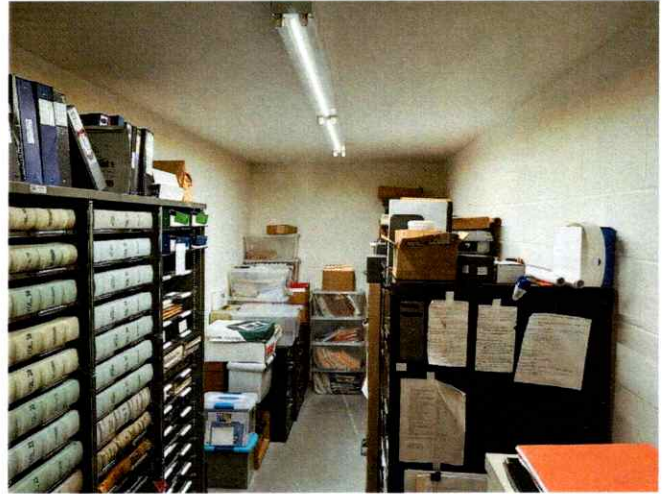
A Rinnai direct wall furnace was recently installed. This heating system services the entire building. The Town Clerk commented that she is cold during the winter months. This is largely due to lack of insulation in the floor as noted in the Envelope section. Additionally, the vault where town records are stored is not conditioned; a request was made to condition the vault space to accommodate the preservation of records and paper documents stored at the facility.

Vault, not conditioned

12	Condition the vault by installing a mini-split heat pump, and adding sensors to monitor the temperature and humidity to keep the levels steady for document storage. The temperature should stay between 68°F and 76°F and the humidity should be in the 35 - 55% range. There are no energy savings associated with this measure because this is a currently an unconditioned space.	\$6,000	N/A	(121)	N/A	N/A	N/A	-	N/A	\$ (382)	(15.71)

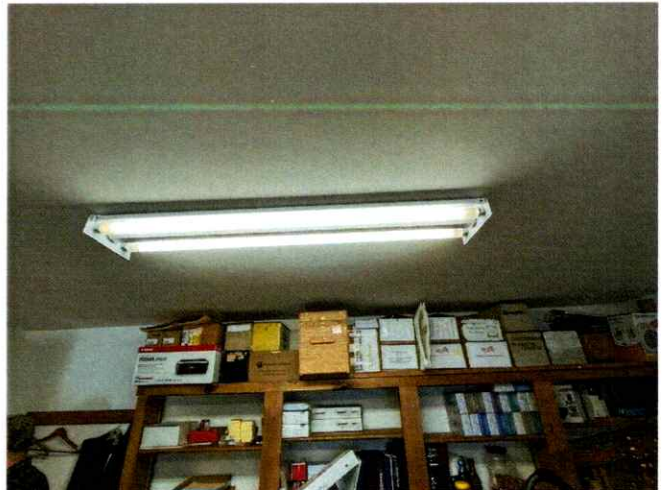
Troffer drop ceiling light fixtures containing retrofitted 34w LED bulbs provide interior lighting in the buildings. The office, vault, and back room, all have troffer lighting. The single bathroom contains one 60W incandescent bulb. The back room has not been converted to LED.

Back room lighting, not yet converted to LED

9	Upgrade interior lighting (3) with ENERGY STAR or DLC certified LED technologies and install occupancy sensors (4)	\$ 760	N/A	N/A	N/A	N/A	N/A	147	N/A	\$44	17.41
10	Floor Option 1: Improve floor structure and comfort by removing the current floor, remediating the mold, installing a vapor barrier, installing insulation, laying a new slab, and putting down a new hardwood floor. It is strongly recommended to consult with a professional flooring / moisture remediation specialist prior to implementing this measure, as every situation is specific.	\$32,063	N/A	130	N/A	N/A	N/A	N/A	N/A	\$408	134.81
11	Floor Option 2: Improve floor structure and comfort by remediating the moisture issues, installing a vapor barrier, and installing insulation. It is recommended to consult with a professional flooring / moisture remediation specialist prior to implementing this measure, as every situation is specific.	\$ 22,800	N/A	130	N/A	N/A	N/A	N/A	N/A	\$ 408	55.88

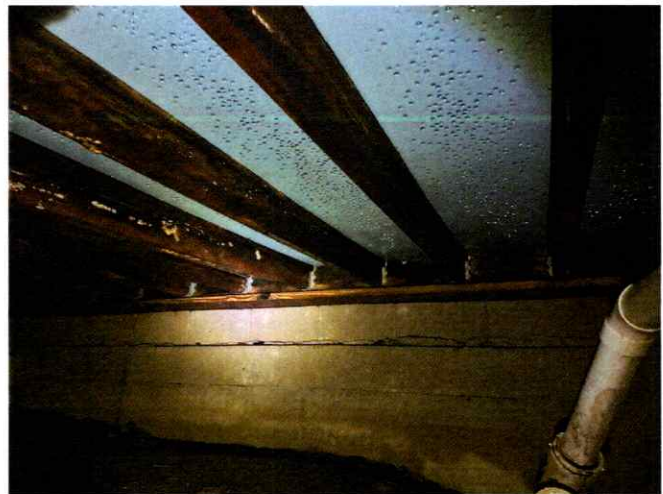
The crawl space contains moisture that is leading to mold and wood decay. The addition has rigid foam insulation between the floor joists, however the original building does not contain insulation underneath the floor. The town clerk shared that her comfort is affected during the winter months by the lack of insulation in the crawl space. There is interest in repairing the water-damaged floor joists, along with insulating the floor. Another idea is to remove the existing floor and its moisture-laded supports, and in-fill the crawl space with concrete. This will allow for installation of a vapor barrier and to seal the underside of the building.

Underneath building addition, showing two (2) inch blue foam insulation between rafters. No tag or R value visible

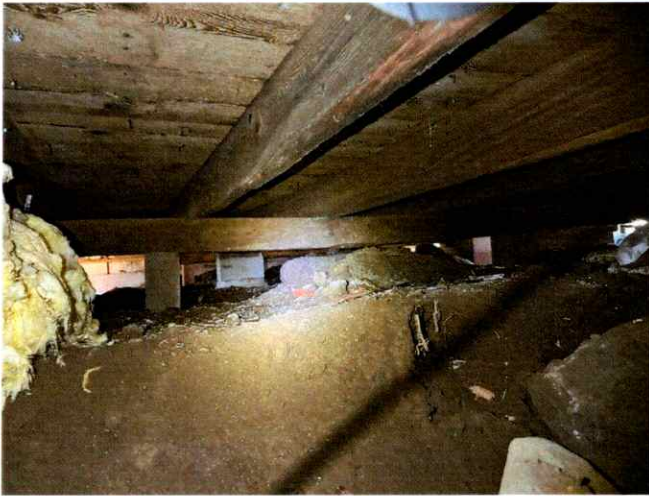
Foundation Type	Building foundations appear to be crawl spaces that are unvented during the winter and vented during the summer.
Basement/Crawl Space	There is crawl space with a dirt floor and no moisture barriers under the building. The access to the crawl space is in the back room. Significant moisture issues and mold were observed in the crawl space.
Basement/Crawl Space Insulation	No insulation present

View from crawl space entrance, looking to inside of the front of the building

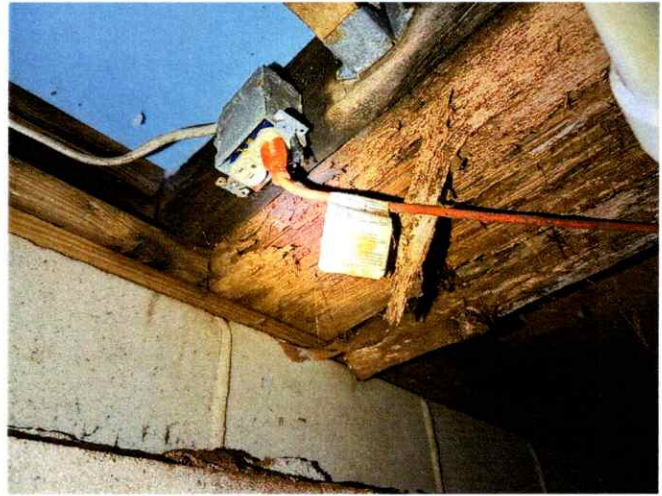
Noting moisture conditions of the joists

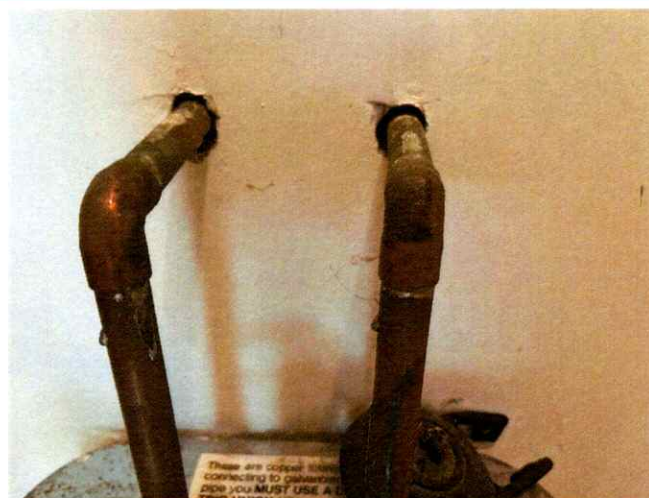
Components	Tank - Direct
Fuel	Electricity
Age	Age unknown, site escort estimates 40 years old
Distribution Pumps	None
Supplementary Storage Tanks	None
Domestic Hot Water System Capacity	2.5 gal
Manufacturer's Rated Efficiency	0.68 EF
Hot Water Piping	Domestic hot water piping was observed to be uninsulated where exposed.
Quantity	One (1)

Copper plumbing penetration from the well pump and tank, to the water heater

6	Replace the office refrigerator with an ENERGY STAR rated model	\$ 250	N/A	N/A	N/A	N/A	N/A	40	N/A	\$ 12	21.04
7	Replace the domestic hot water tank with higher efficiency (.99 EF), point of use model.	\$ 900	N/A	N/A	N/A	N/A	N/A	166	N/A	\$ 49	18.25
8	Install insulation on DHW lines to R-4	\$ 50	N/A	N/A	N/A	N/A	N/A	39	N/A	\$ 12	4.32

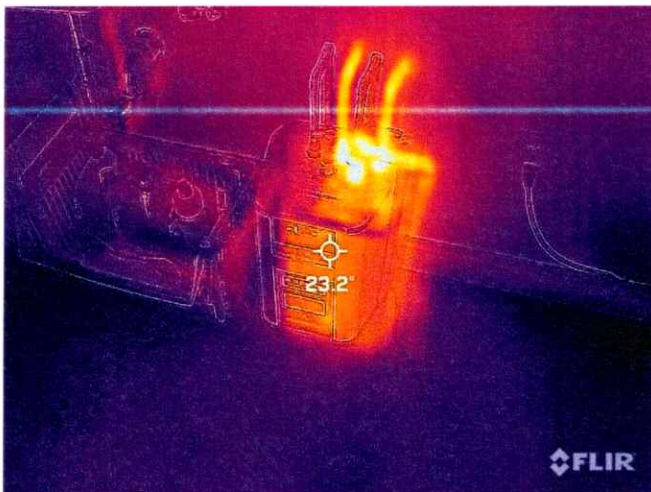
Infrared Equipment	Flir iPhone compatible camera
Outdoor temperature	63°F
Indoor space temperature	66°F
Infrared Comments	IR camera indicates DHW heater is radiating 73.8°F, the windows read 76°F, and there is an indication of air intrusion in the northeast corner of the main office, reading at 62°F. All of this indicates a need to examine air sealing and window issues, as well as insulating specific equipment.

IR photo of water heater, temperature measured in celcius

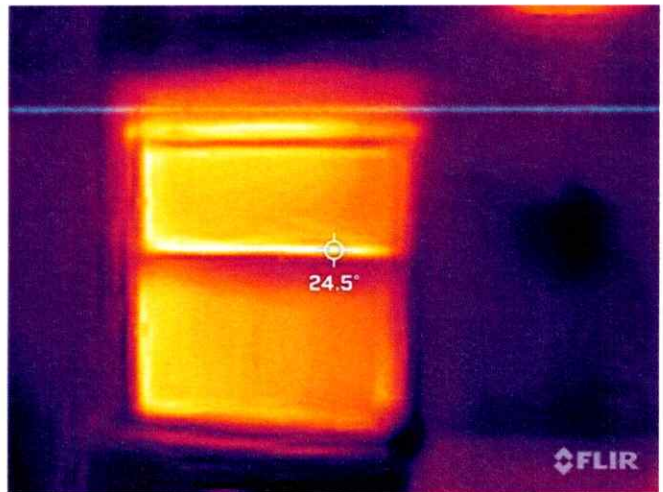
IR photo of double hung window, typical reading

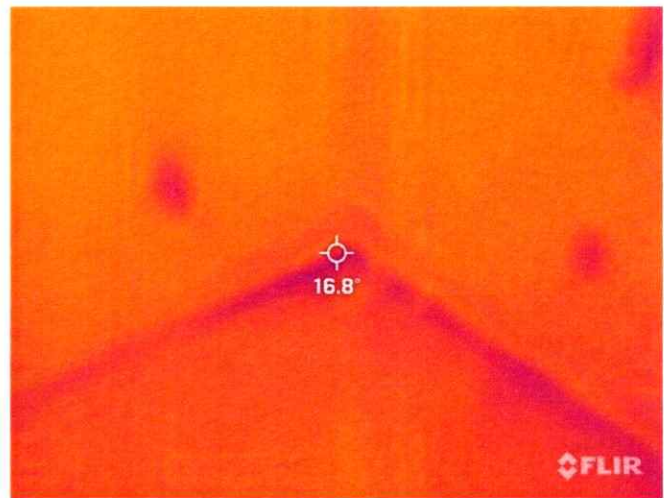
Blower Door Equipment	Minneapolis blower door system
Building Volume	9,120 Cubic Feet
Leakage Rate @ -50 Pa (CFM50)	726.5CFM/hr
Leakage Rate ACHN50	4.66 Air changes per hour
Noted areas of infiltration	Crawl space (uninsulated), moderate air flow from the floor thought the baseboard. No sealing from foundation to sill plate.

Indication of exterior air intrusion, main office, north east corner

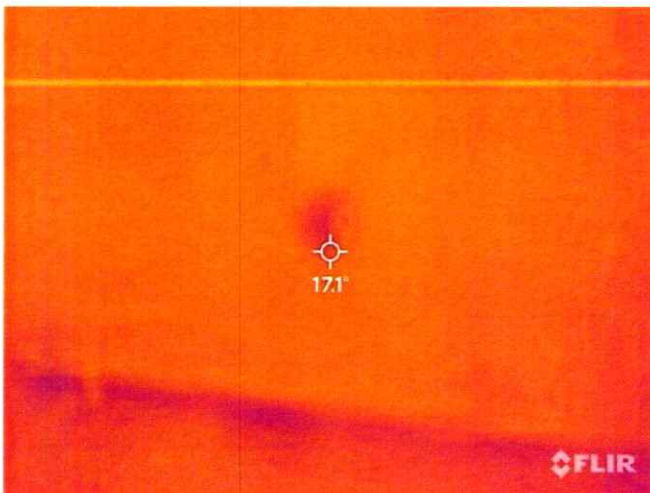
Indication of exterior air intrusion, east wall

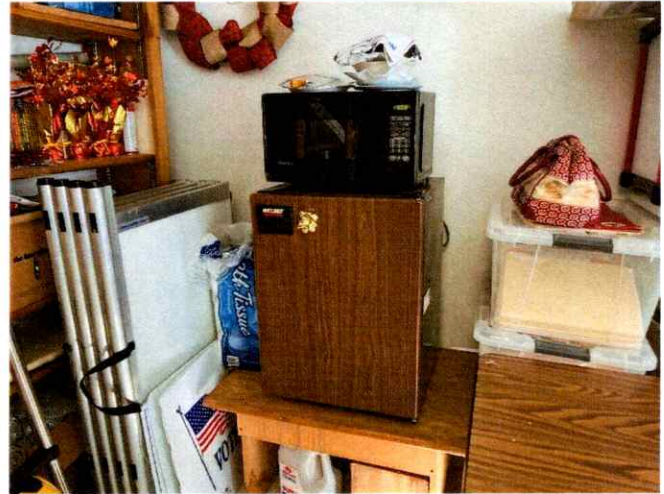
Item	Type	Estimated Age & Condition (per sampling)
Refrigerator (mini-fridge)	This unit is not Energy Star qualified 2.5 cubic feet Freezer location: N/A Manufacturer/s: Sanyo Electric Co. Estimated Annual Consumption: 320 KWh	1 unit - 100% 20+ years (Poor)

Mini fridge and microwave
